Re: Visual Site Inspection  
American Tape Company  
Marysville, Michigan  
MID 061 862 926

**PRELIMINARY ASSESSMENT/  
VISUAL SITE INSPECTION**

**AMERICAN TAPE COMPANY  
MARYSVILLE, MICHIGAN  
MID 061 862 926**

**FINAL REPORT**

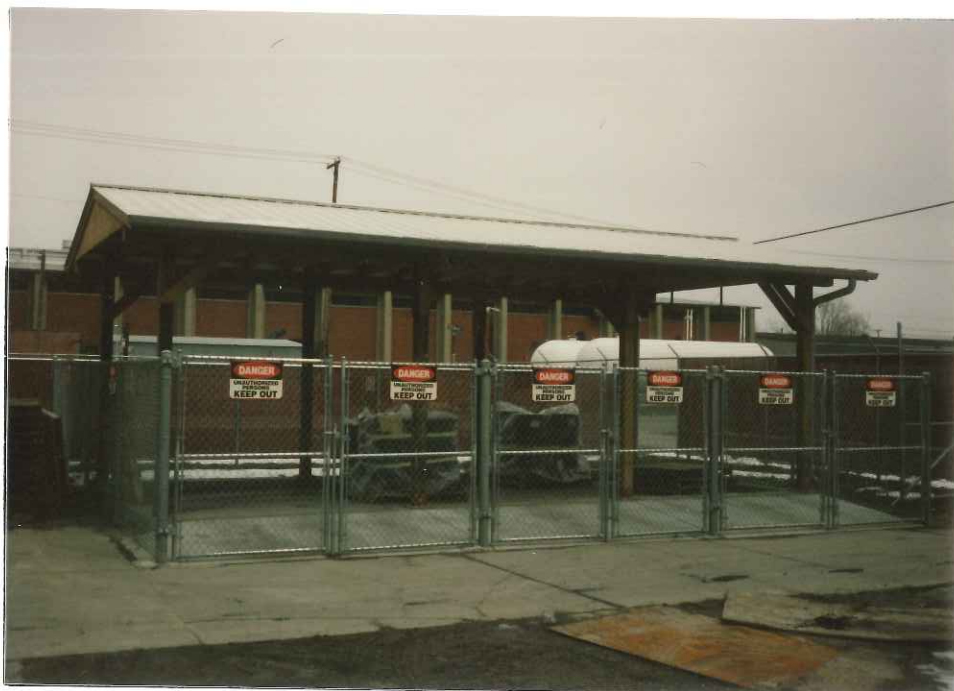
Photograph No. 1

**Observations:** The storage area is new and appeared to be in very good condition. Ten 55-gallon drums were in storage at the time of the inspection. Four contained off-specification solvents, three contained waste adhesive, and three contained solvent-contaminated oil. PRC noted no evidence of release (see Photograph No 1).

Description: Hazardous Waste Storage Area. Floor is raised in the foreground and curbed in the back. Some drums are being stored and are wrapped in plastic.

**Recommendations:**              PRC recommends no further action for this SWMU at this time.

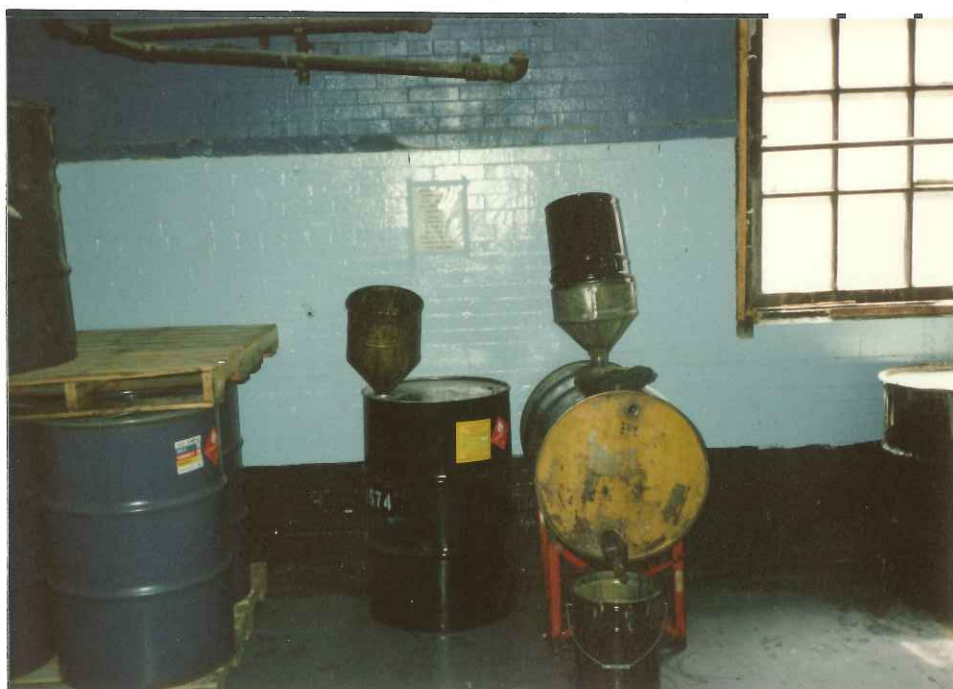
Photograph No. 2

**Observations:** The drum observed during the inspection appeared to be in good condition. The funnel in one of the drums was open (see Photograph No. 2).

**Observations:** At the time of the inspection, some oil/water mixture was being poured into the unit. The unit was about half full, probably mostly oil. The unit appeared to be in good condition. No cracks in the floor were visible. PRC observed no evidence of release (see Photograph No. 2).

Description: Solvents Satellite Accumulation Area (SWMU 2) is on the left. The Oil/Water Satellite Accumulation Area (SWMU 5) is on the right. Drums to the far left contain product. Water is drained out the bottom spigot of oil/water drum.

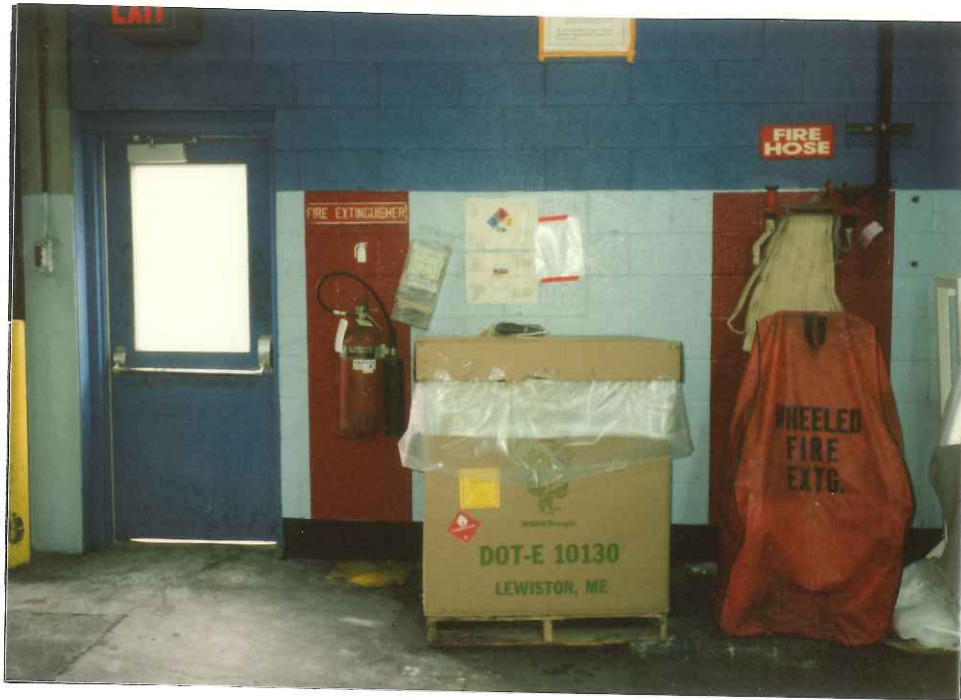
Photograph No. 3

Observations: Fire extinguishers were located near the boxes. The floor did not appear to have substantial cracks and no floor drains were observed. PRC was told that the boxes contained filter socks at the time of the inspection. PRC did not look into the boxes to observe the amount of waste accumulated in them. PRC noted no evidence of release (see Photograph No. 3).

Description: A typical Gaylord Box. The container is lined with plastic. Fire extinguishers are located nearby.

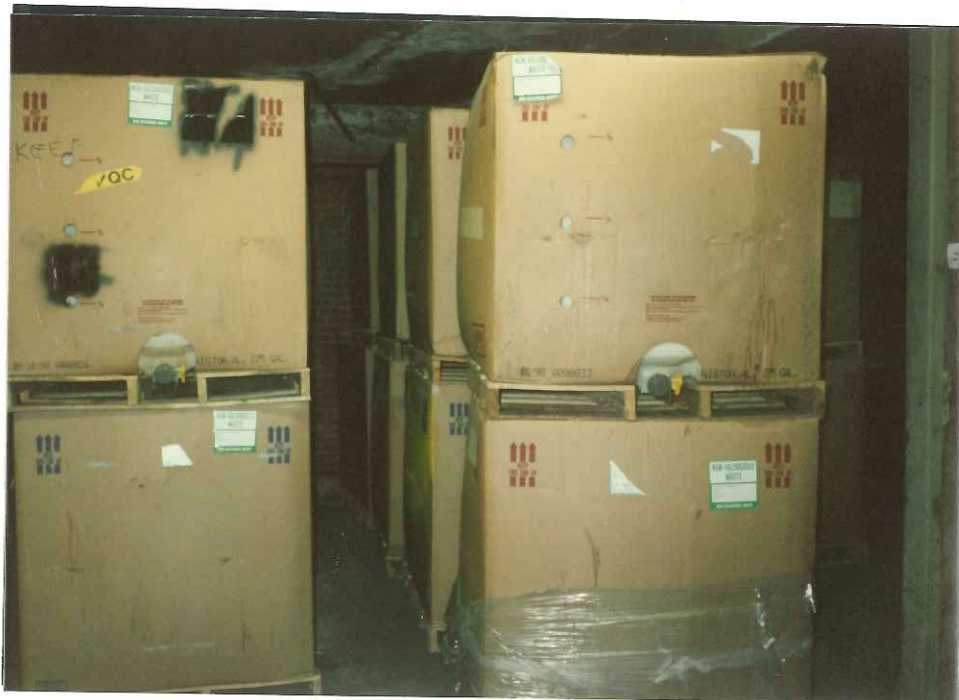
Photograph No. 4

Description: Silicone is stored in these boxed bulk tanks. These containers are emptied through spigots located at their bottoms. Box at top right is almost full. All containers are marked "Nonhazardous Waste."

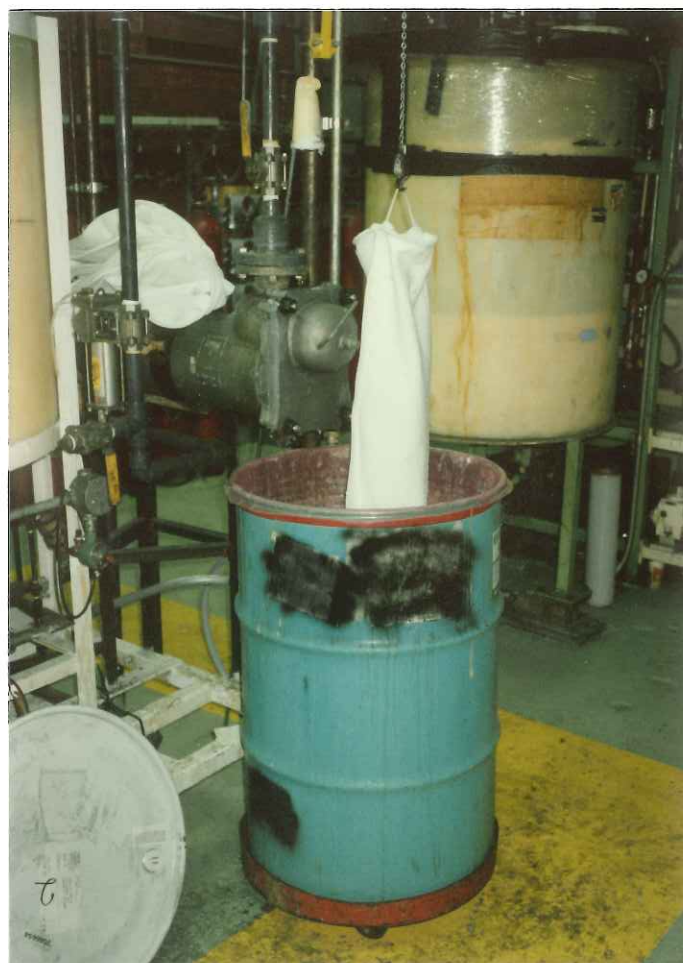
**Observations:** At the time of the inspection, one drum was about one-tenth full. It had a filter sock dripping into it (see Photograph No. 6). Another drum was full and awaiting transfer to the Hazardous Waste Storage Area (SWMU 1). Although the floor in the adhesive mixing room had numerous pock marks, it had been painted, which appeared to be acting as a sealant. No release from this unit was observed.

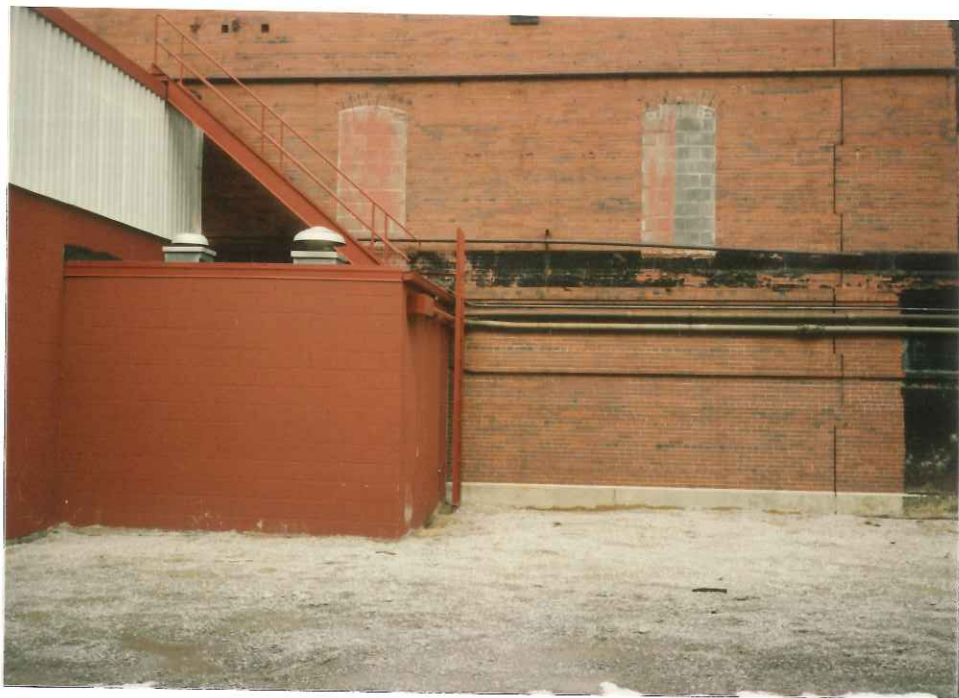
Photograph No. 7

USTs No. 1 through 3 are an AOC because they have leaked solvents and have been involved with numerous spills at the facility. These 12,000-gallon steel tanks were installed in the late 1960s to store toluene and rubber solvent. In 1990, the tanks were emptied, cleaned, and filled with cement. ATC notified MDNR of the leaking tanks and plans to pump and treat the ground water and perform in situ treatment of contaminated soil in conjunction with the RCRA closure of the Former Hazardous Waste Storage Area (SWMU 8). At the time of the inspection, the tanks were buried and no remediation had begun (see Photograph No. 7). The facility is awaiting state approval for the amended closure and remediation plans. ATC has retained the services of Techna to manage this project.

Description: The Former Hazardous Waste Storage Area (SWMU 8) used to be located here.  
The leaking USTs No. 1 through 3 (AOC 2) are located under the foreground.

PRC recommends closure activities for the Former Hazardous Waste Storage Area (SWMU 8) continue as scheduled. In addition, remedial activities planned for the leaking USTs (AOCs 1 and 2) should proceed as planned once those plans are approved by the state.

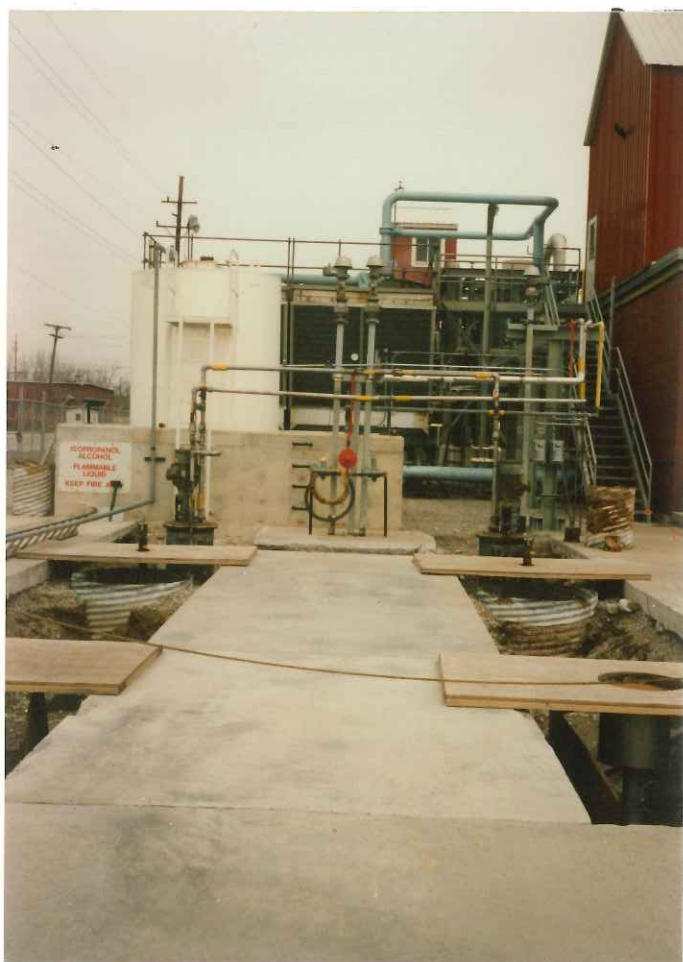
Photograph No. 8

Directly east of USTs No. 202 and 203 (AOC 1) was UST No. 201. This tank was a 30,000-gallon steel tank used to store No. 2 fuel oil. This tank was installed in 1982, filled once, and never used. This tank was not leak-tested, and it was excavated in June 1992 along with USTs No. 202 and 203 (AOC 1). The new USTs have been installed in the area of this tank (PRC, 1992).

USTs No. 202 and 203 are an AOC because they have leaked solvent material. These 20,000-gallon steel tanks were installed in 1982 to store recovered and virgin solvents. ATC notified MDNR of the leaking tanks and excavated the tanks in June 1992. The facility plans to pump and treat the contaminated ground water and remediate the contaminated soil via in situ air stripping pending state approval. New solvent storage tanks have been installed at the location of UST No. 201. At the time of the inspection, the tanks were in the early stages of removal (see Photograph No. 8). ATC retained the services of Techna to manage this project.

Description: Fuel Oil UST No. 201. This tank is no longer at the facility and new USTs for solvents have been installed here.
